1 St Silin's Church

The first church on the site dates from the thirteenth century. It was a cruciform shape with an aisled nave, giving it a double nave and two chancels, north and south. This church was razed to the ground during Owain Glyn Dŵr's rebellion in the fifteenth century.

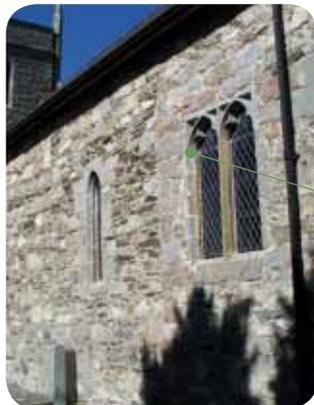
The quoin line in the stonework is thought to be the southwest corner of the transept of the original church.

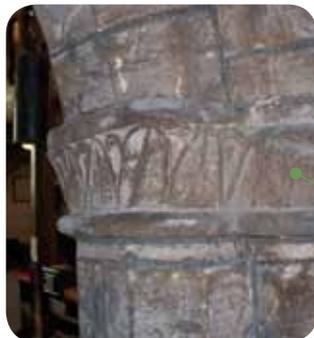
The carved corbel stone to the western most pillar of the arcade is thought to be Early English in style and therefore dates from the original church. Its survival is a vital clue in establishing the design and position of the early church as it tells us there was an arcade on this spot, and therefore there must have been a south aisle.

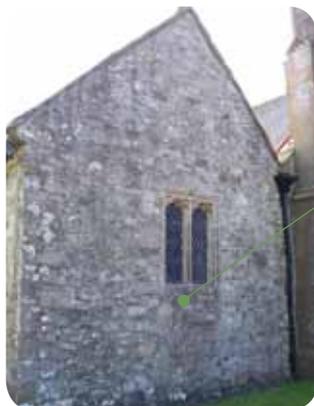
Evidence of a door in the west gable in the stonework below the window suggests this was the main west entrance to the original church. The door was later filled in and the space used as a window.

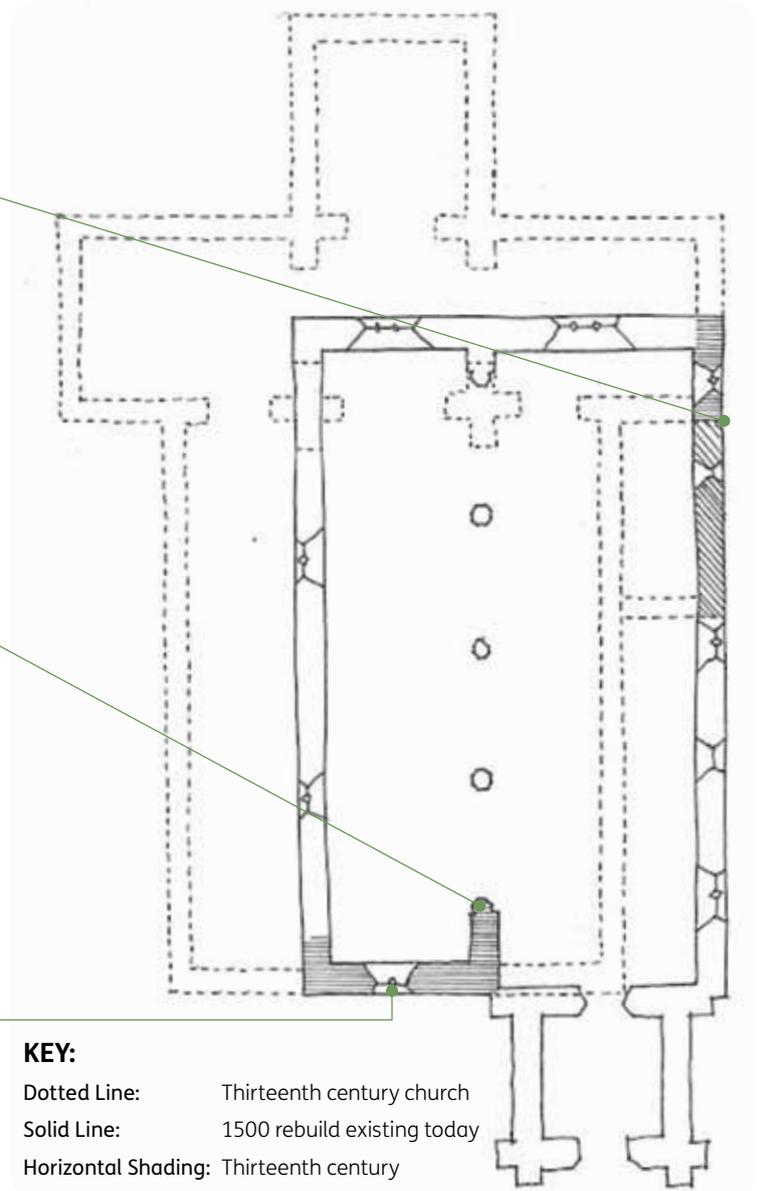
By 1500 the church had been rebuilt around the remains of the old one. Traces of the thirteenth century church can be seen in the stonework of today's building.

- Dotted Line: Thirteenth century church
- Solid Line: 1500 rebuild existing today
- Horizontal Shading: Thirteenth century church in present church
- Diagonal Shading: Early fourteenth century chapel in present church

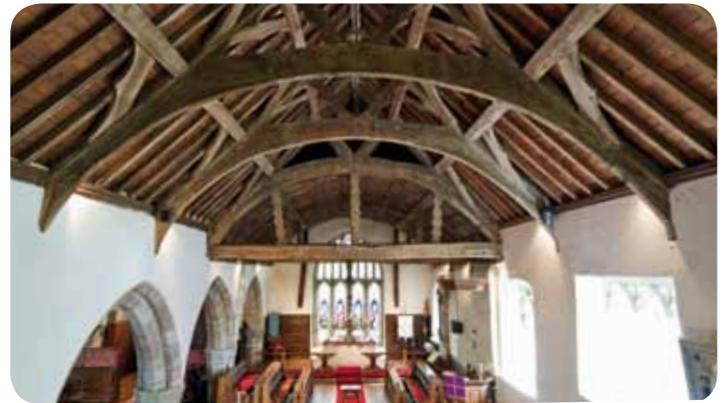
In 1890 the church was restored under the direction of the Victorian architect Arthur Baker. Unlike many Victorian restorations, this work was done with sensitivity and with little loss to the historic fabric. The most dramatic change was the removal of the plaster ceiling revealing the stunning fifteenth century arch-braced roof in the south nave and the beautiful and intricate wagon ceiling at the east end.
